## Possible Causes of Failure- Rotor -Tech Positive Displacement Rotary Gear Pumps

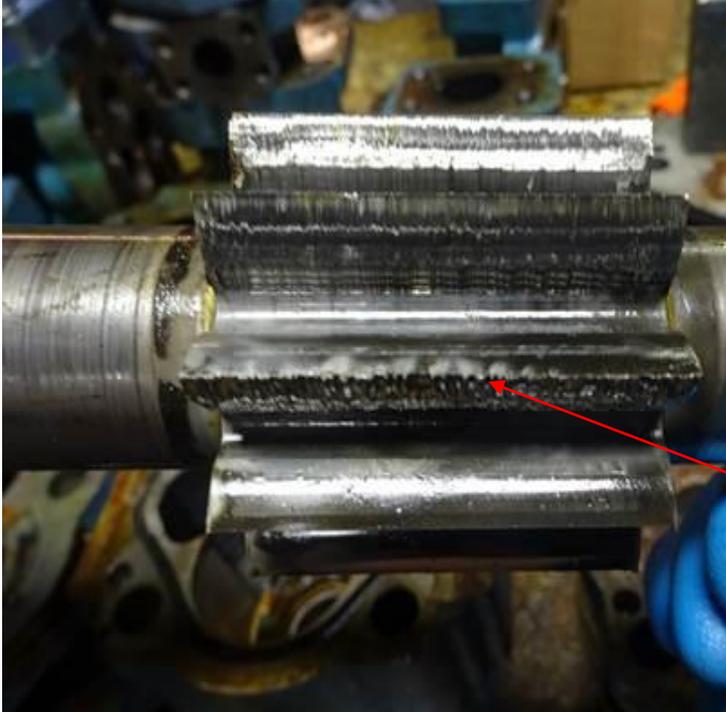
<p><b><u>Fine Grit/Trash in Glycol</u></b> Lack of filtration will cause striations in the gears result in early pump failure.</p>	<p>We recommend 50 -75 Micron Filter elements on the suction side of the pump.</p>
--	--	--

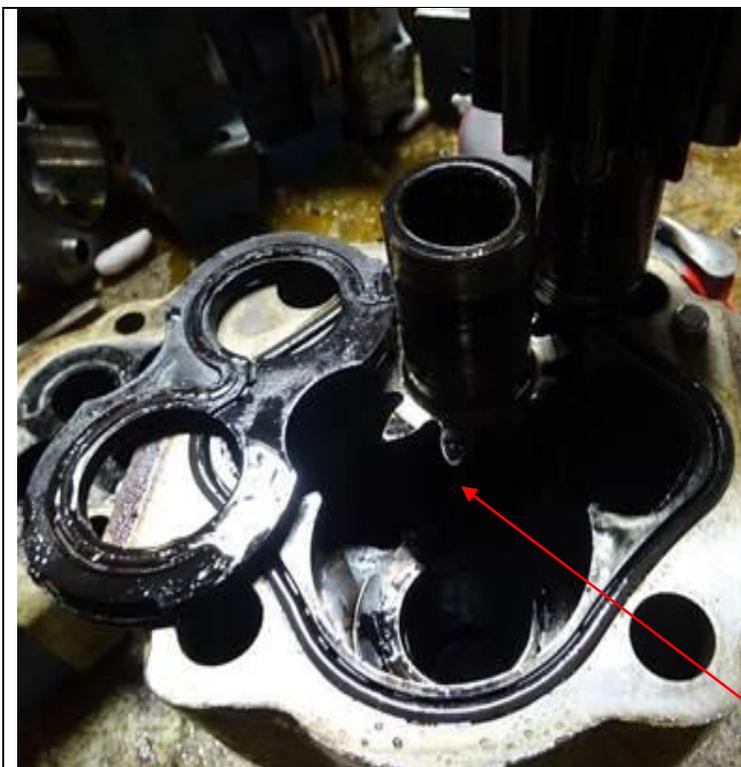
**High Heat**

Our pumps are rated for fluid temperatures up to 200 degrees F or a minimum viscosity of 4cp. This is because the viscosity of the glycol at temperatures above 200 degrees drops below what is suitable for our pump. Our pumps rely on the fluid being pumped for lubrication.

We recommend keeping the temperature below 200 °F. Check heat exchanger for any blockage or insure that you have plenty of fluid exchange coming from your contactor.

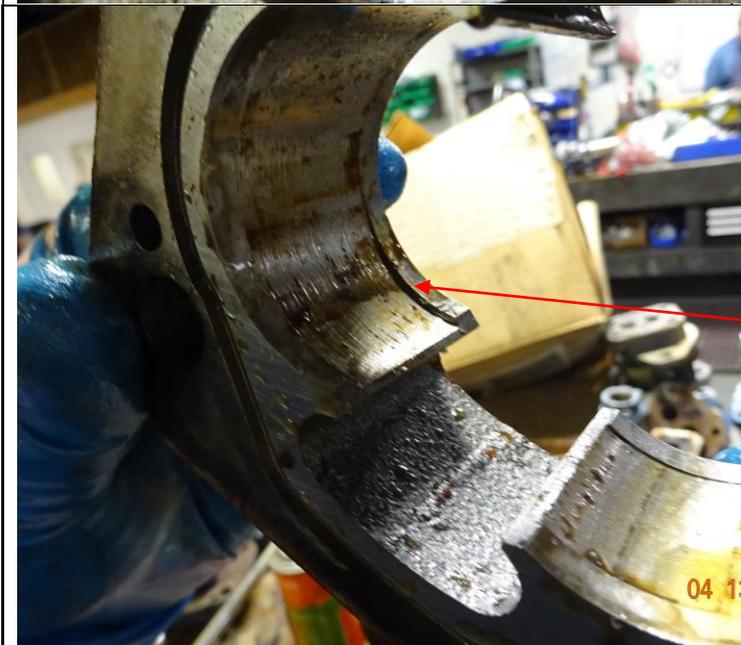
**Improper Start-up-** (please see Rotor-Tech start-up procedures)

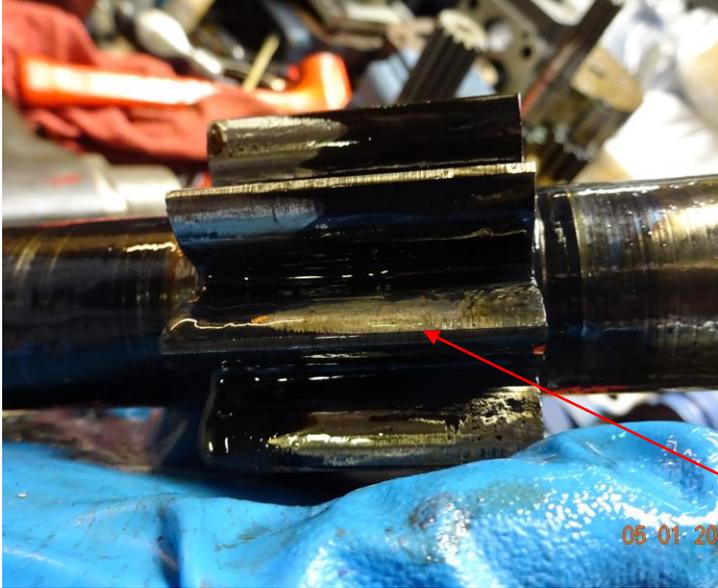
<p>05 01 201</p>	<p><b><u>Miss-alignment-</u></b> Our pumps have very tight clearances. If the hard pipe on the suction or discharge are under stress it can cause alignment issues and uneven wear leading to early pump failure.</p>	<p>We recommend installing flexible hoses with a minimum of 12'' for each 1'' in pipe diameter for both the suction and discharge lines.</p>

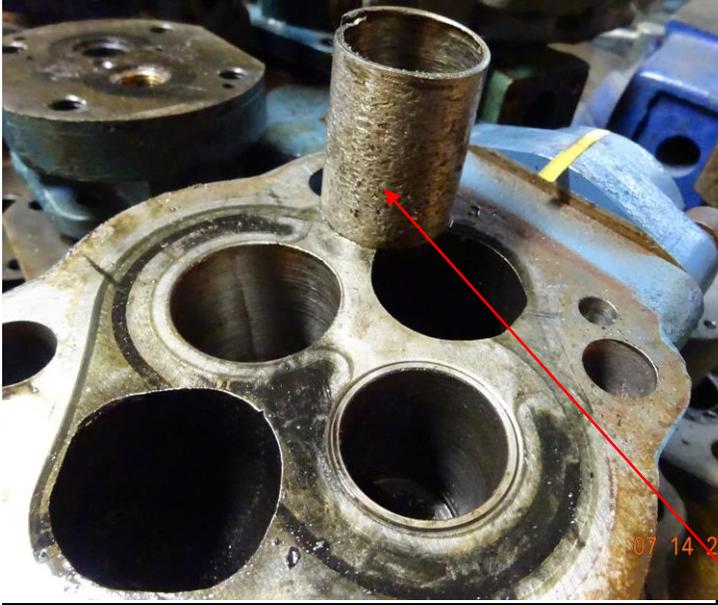
<p>07 14 20</p>	<p><b><u>Pump Ran Dry-</u></b> Our pumps are rated for atmospheric flooded suction. Our pumps rely on the fluid being pumped for internal lubrication during operation. If the pump is operated without adequate fluid internal damage will occur.</p>	<p>Please maintain flooded suction.</p>
